Conference or Workshop Item

Impacts from climate change related hazards in high-mountain areas: A review of assessment techniques

Christian Huggel¹

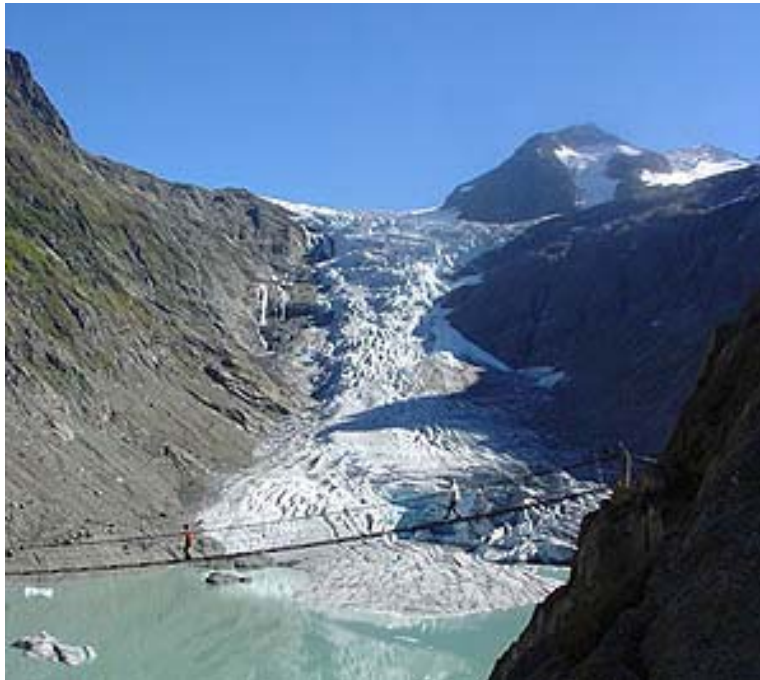
Figure 2. The rapidly retreating tongue of Trift glacier in the Swiss Alps with the growing lake which represents a potential danger for the downstream areas. A hanging bridge had to be built because the traditional alpine route is no longer accessible due to lake formation (photo: KWO, 2005).

conditions (i.e. mainly the bedrock barrier) make the possibility of full and sudden lake failure unlikely but downstream structures could nevertheless be seriously affected by smaller potential floods. In addition to the growing hazards, the glacier retreat and lake formation made the track to a frequently visited alpine hut inaccessible and a hanging bridge had to be built instead (figure 2).
